Date: 3/11/2015

From: Tariq Khraishi, PhD

Subject: Expert report on the injury case of Nedra Denison

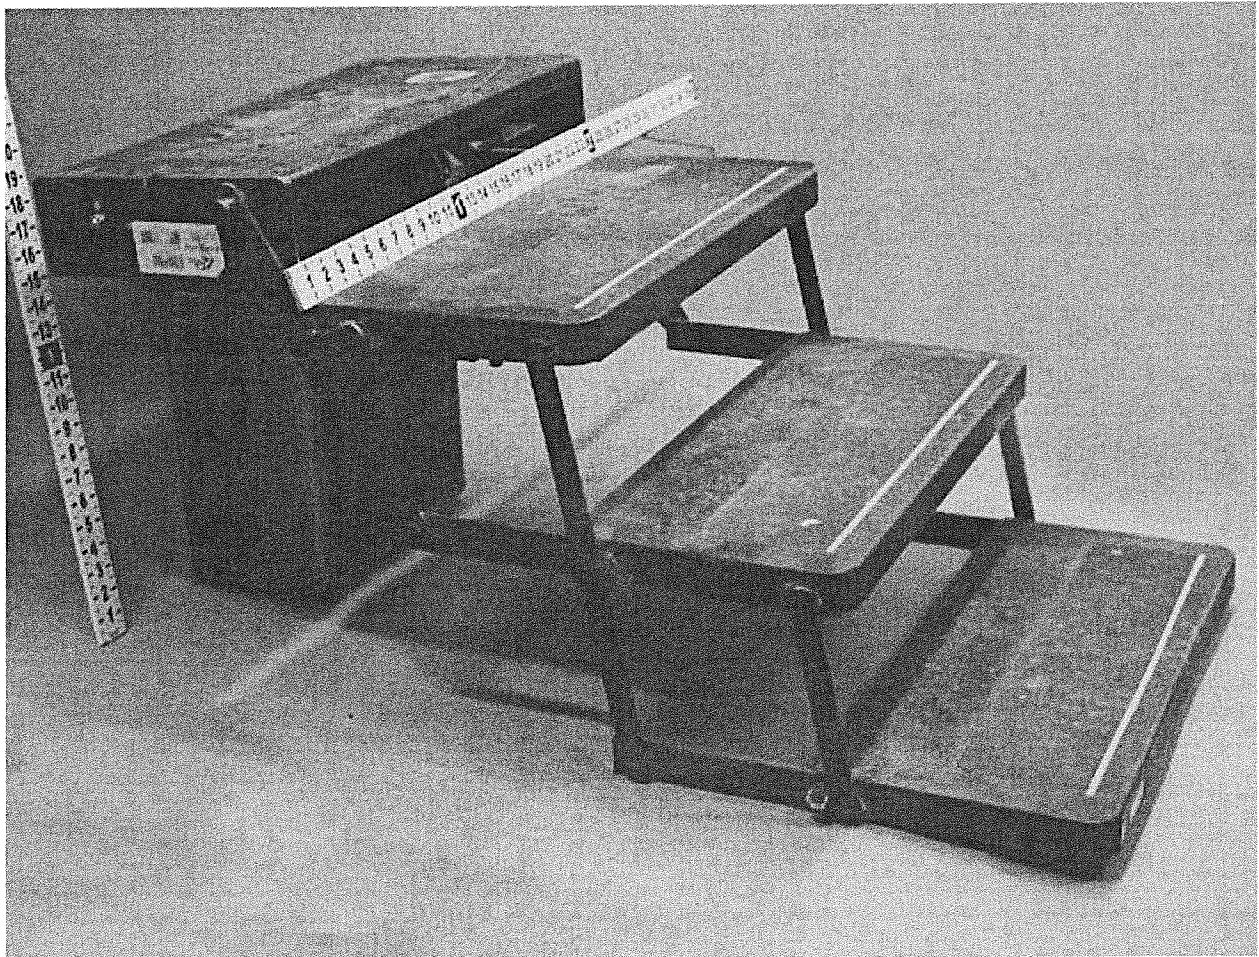
TK has examined the broken steel steps. The fracture occurred in the area next to a welding spot. This is a heat-affected zone. This indicates either a defective; craftsmanship/fabrication and/or materials. For example it could indicate an embrittled material with marteniste formation in the steel (Note: martensite is a very brittle phase of steel). Also, it could indicate improper heat treatment of the weld area after welding to avoid brittle spots (i.e. easily-fracturable spots).

Take a look at the broken steps shown in Figure 1. On the left-side of the picture, there is a top link that broke and caused Nedra's losing balance. The link that broke is highlighted in a blue circle (Figure 2). This link links the top step with another long arm in this mechanism. If you are looking at steps from outside while standing in front of them, the broken link would be on the left. Figure 3, which is a zoomed in image, shows the extent of the fracture into the width and thickness of the link. The loss of stiffness in the structure due to this large crack caused Nedra to lose her balance and fall.

Figure 1. Picture of the broken steps

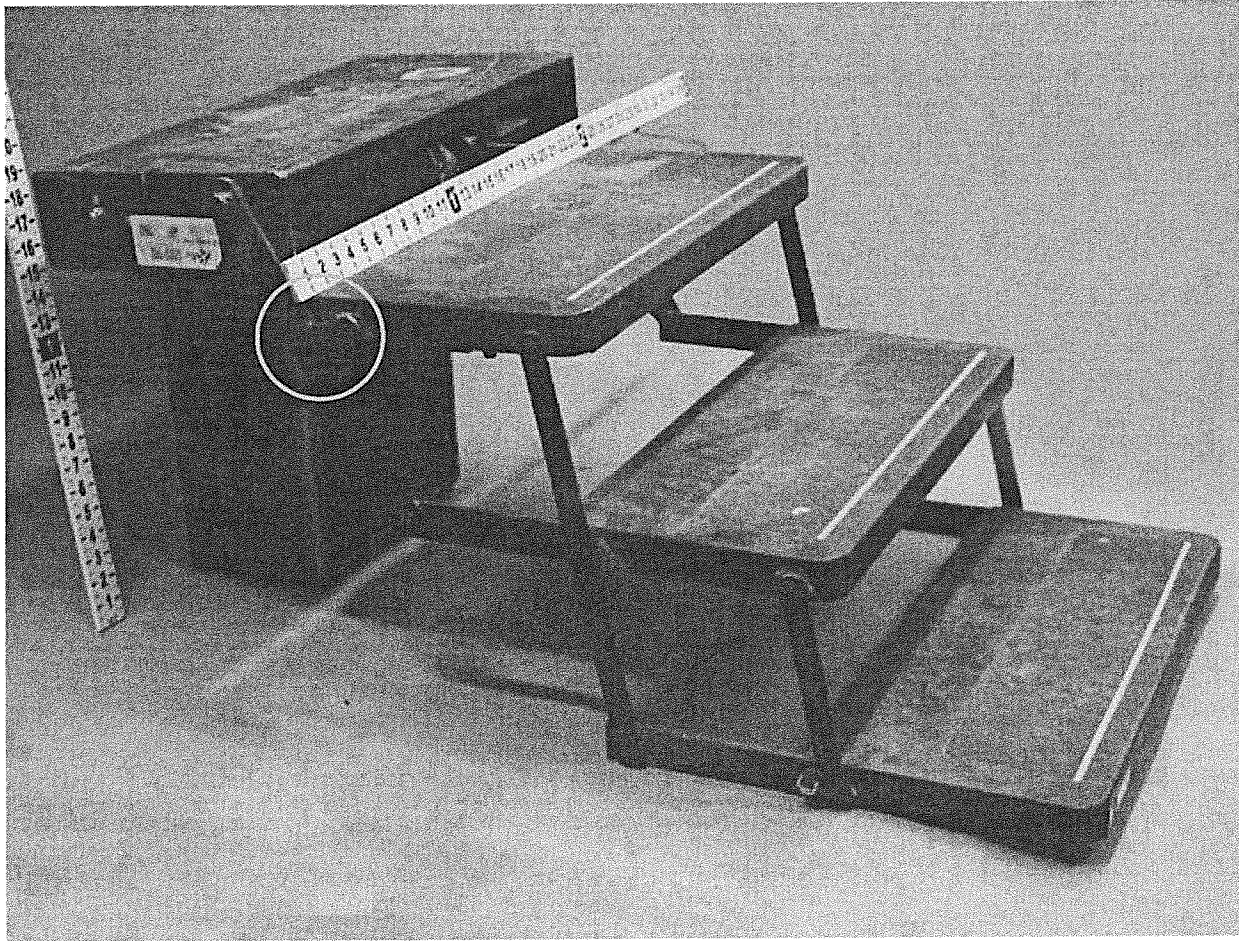
This fracture caused the steps to loose their horizontal leveling (even by a few degrees) and therefore were directly responsible for unexpecting Nedra losing her balance and falling (and thus getting badly injured), i.e. destabilizing this structure/steps.

Figure 2. Picture of the steps with broken link in a blue circle
